Air Safety and Aviation Risks Handbook

Chapter 1 - Air Safety

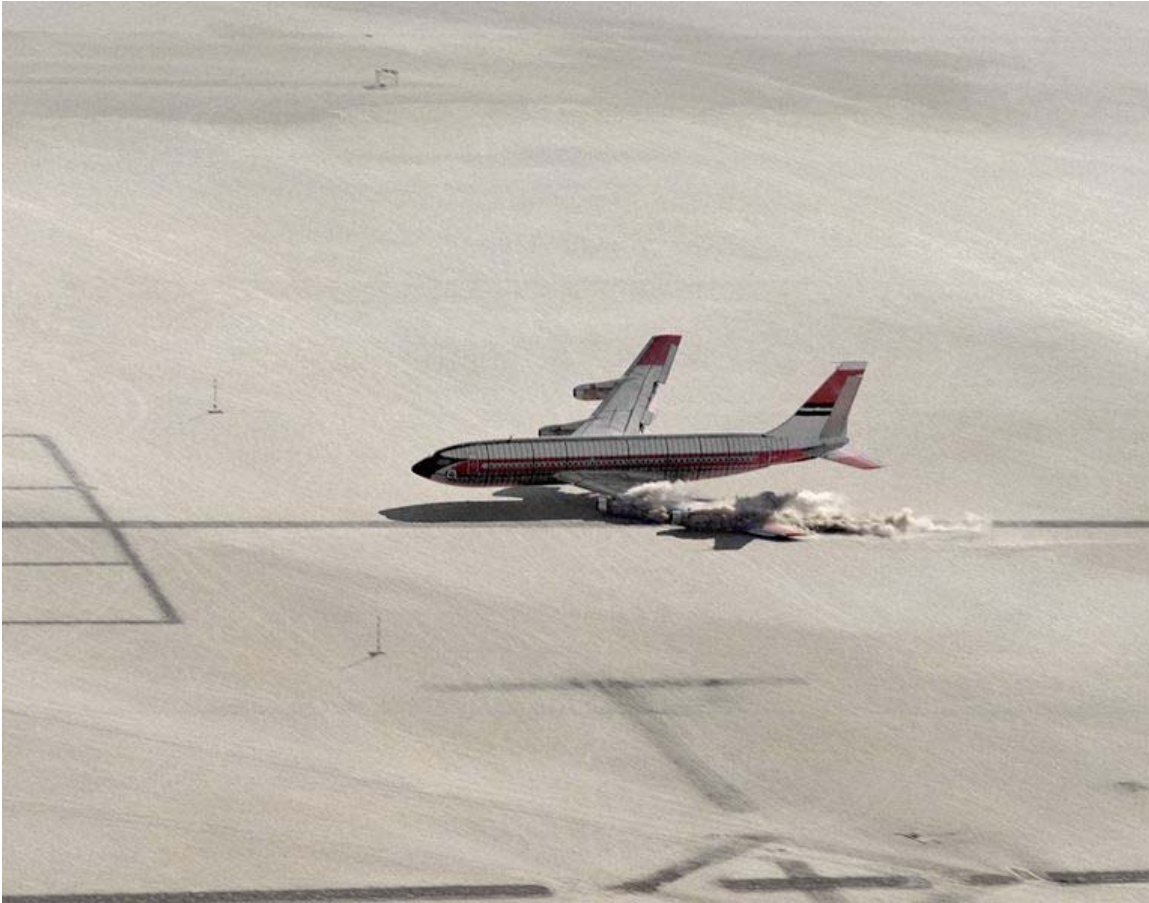
NASA air safety experiment. The airplane is a Boeing 720 testing a form of jet fuel containing the additive FM-9, known as "Antimisting kerosene" (AMK), which formed a hard-to-ignite gel when agitated violently, as in a crash.

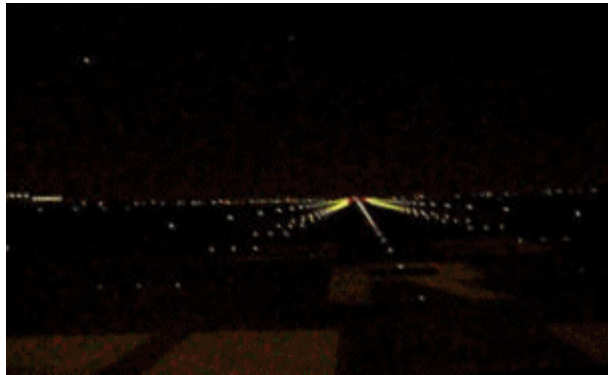
FAA flight simulator showing veiling **glare** where it is hard to see through the light to the background scene. Light level $5.0 \mu\text{W}/\text{cm}^2$; for example, a legal 5 mW laser pointer at 1,200 feet (365 m).

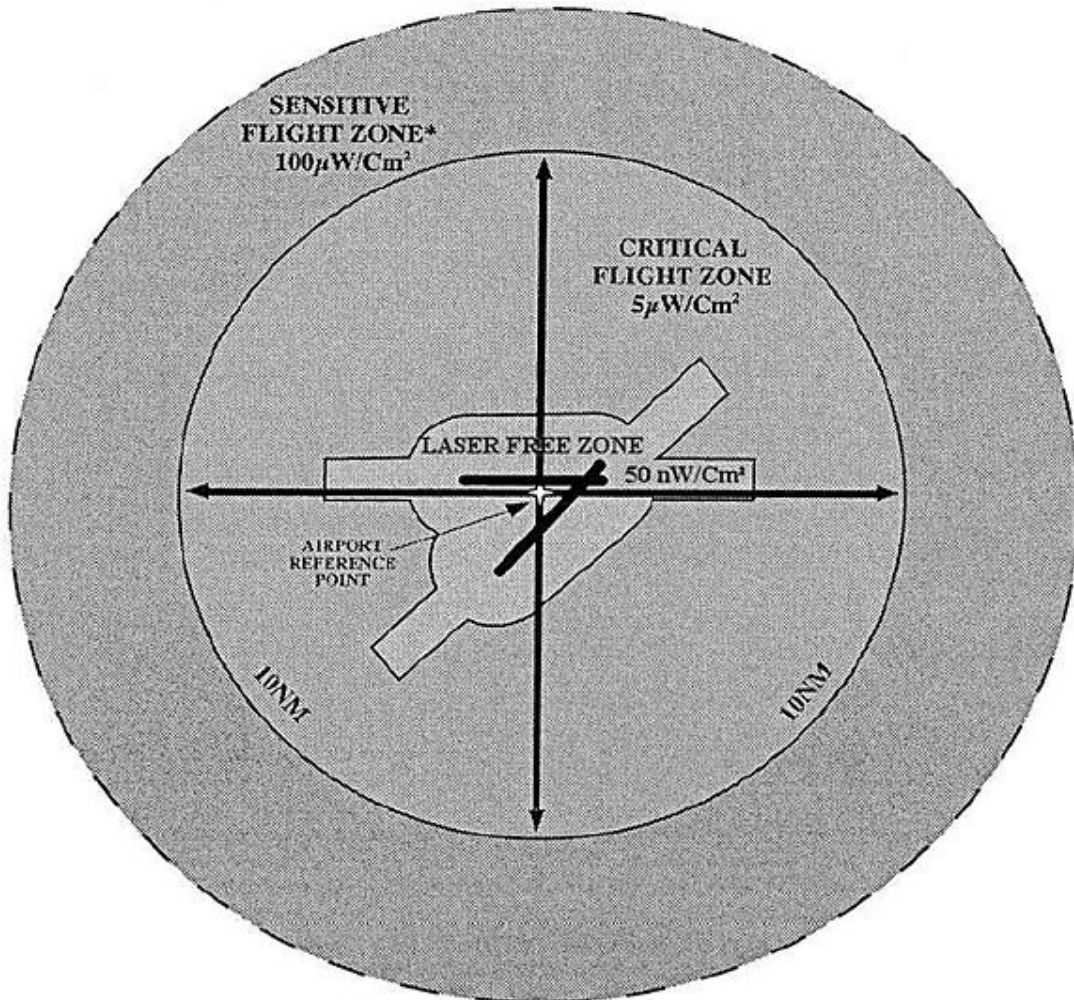
The U.S. FAA Critical Flight Zone extends horizontally 10 NM (18.5 km) around the airport, and extends vertically to 10,000 feet (3,050 m) above ground level. The optional Sensitive Flight Zone is designated around special airspace needing bright-light protection.

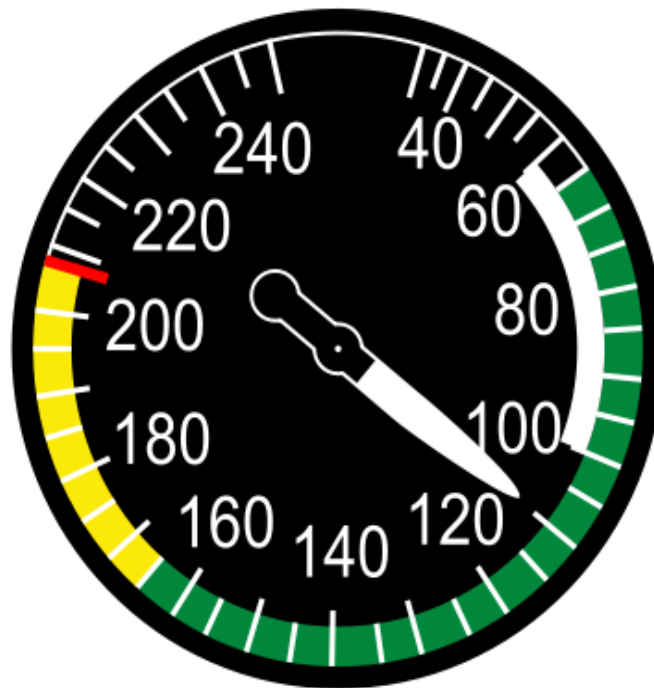
The airspeed indicator is often used to indirectly predict stall conditions.

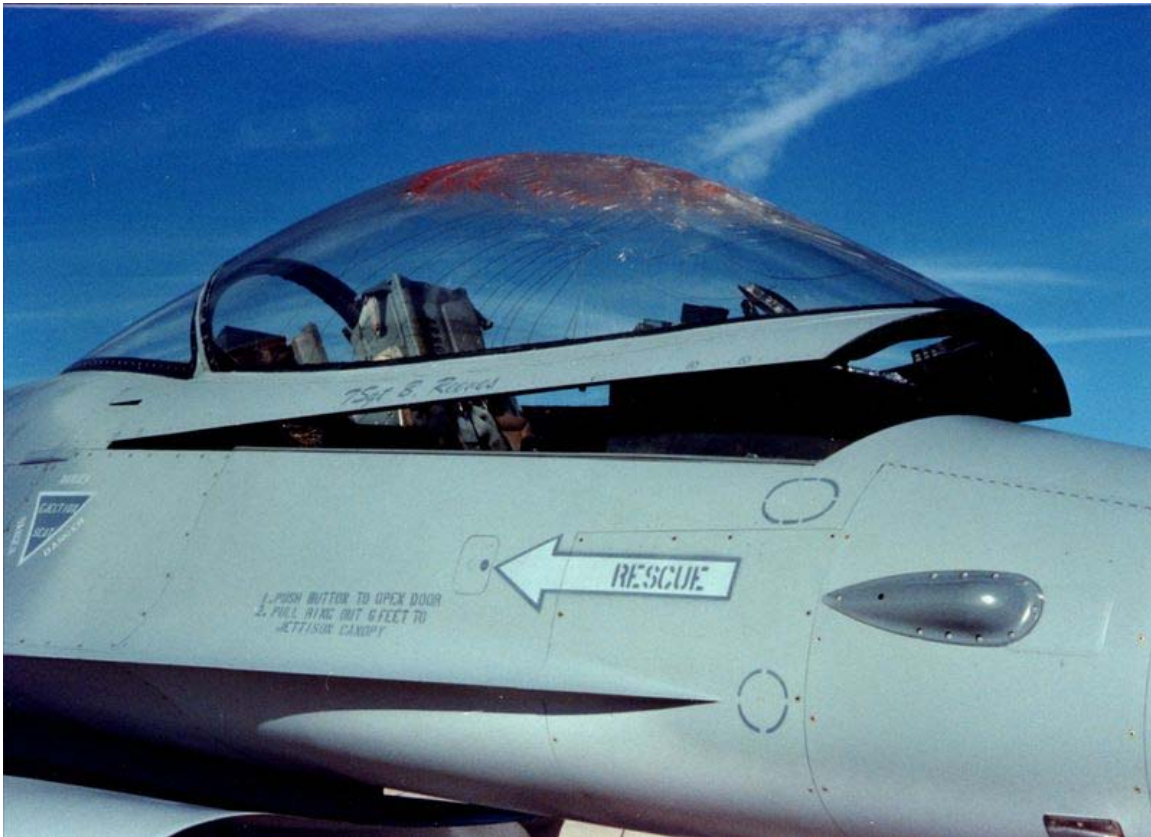
F-16 canopy after a bird strike

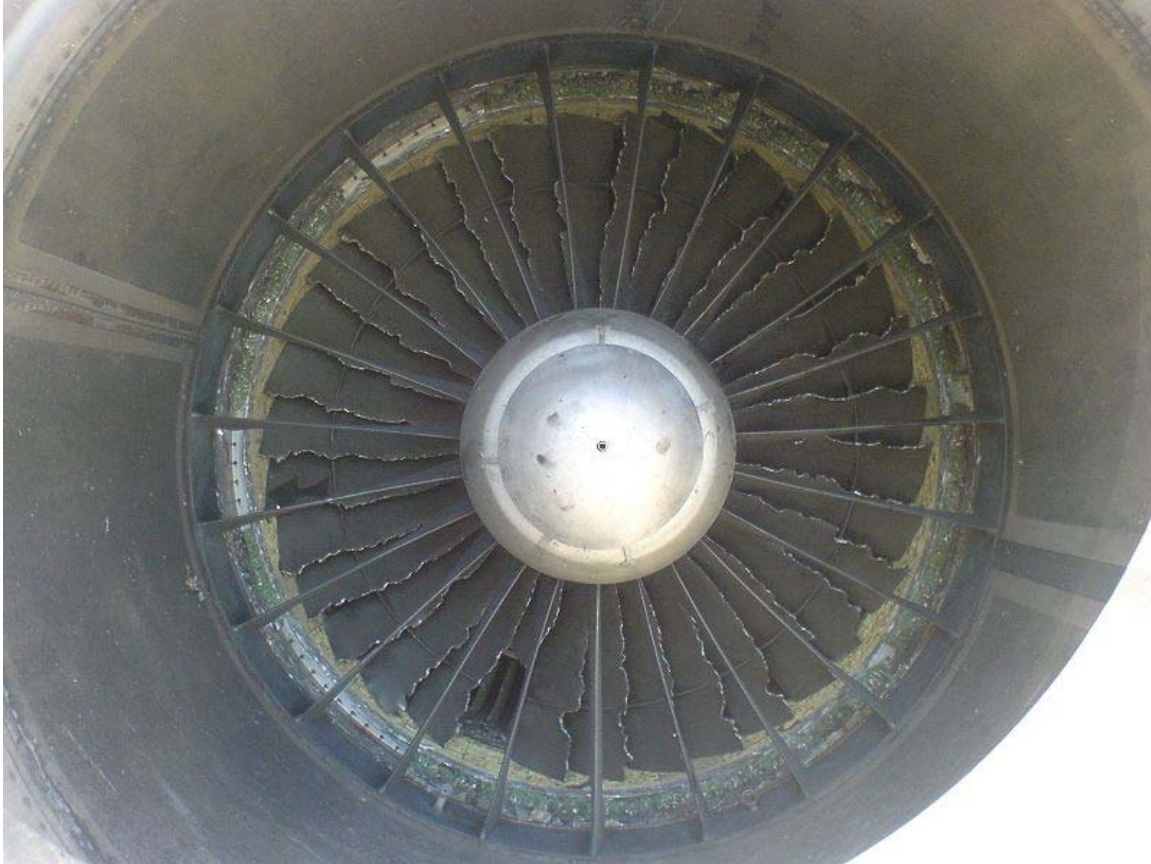
View of fan blades of JT8D Jet engine after a bird strike

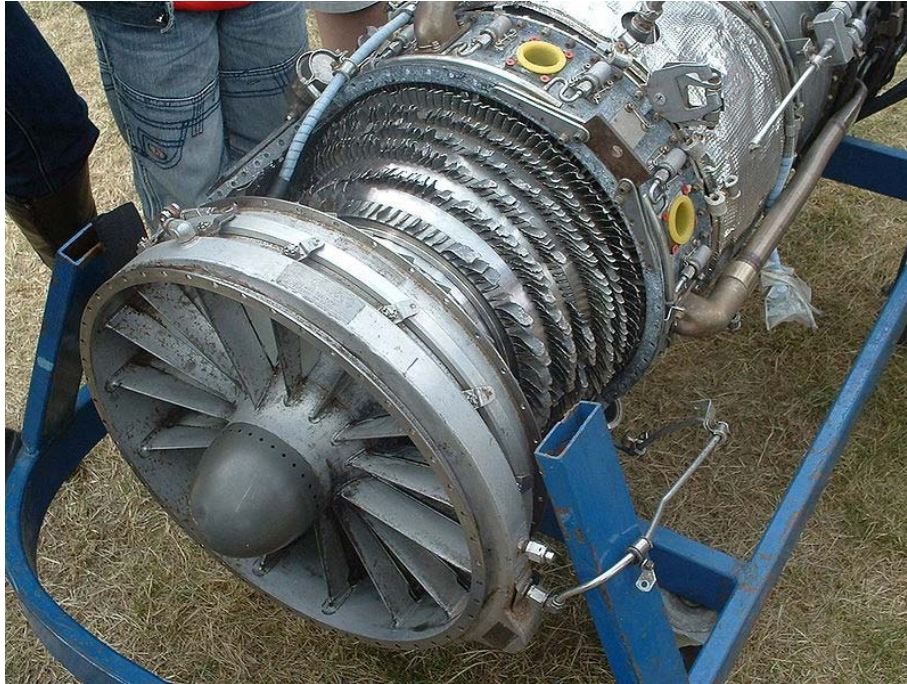
Inside of a jet engine after a bird strike

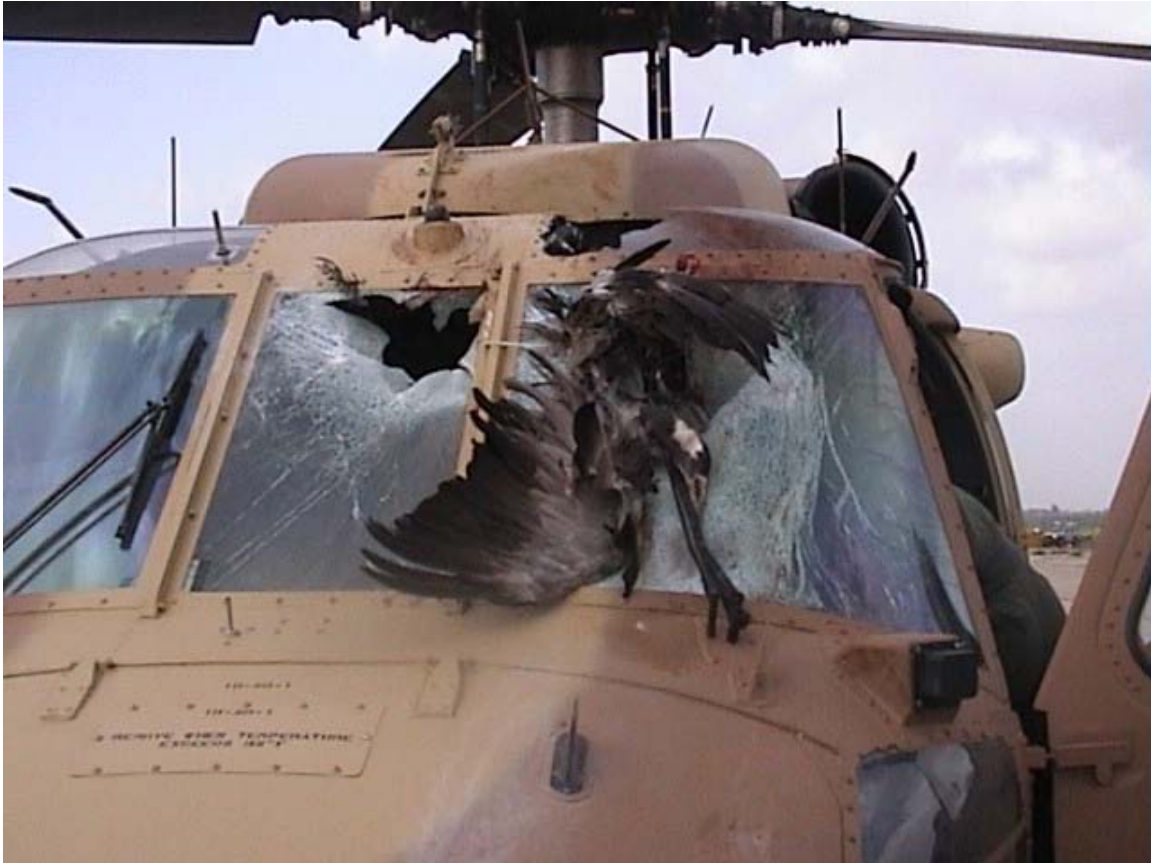
A UH-60 Black Hawk after a collision with a Common Crane, and resulting failure of the windshield.

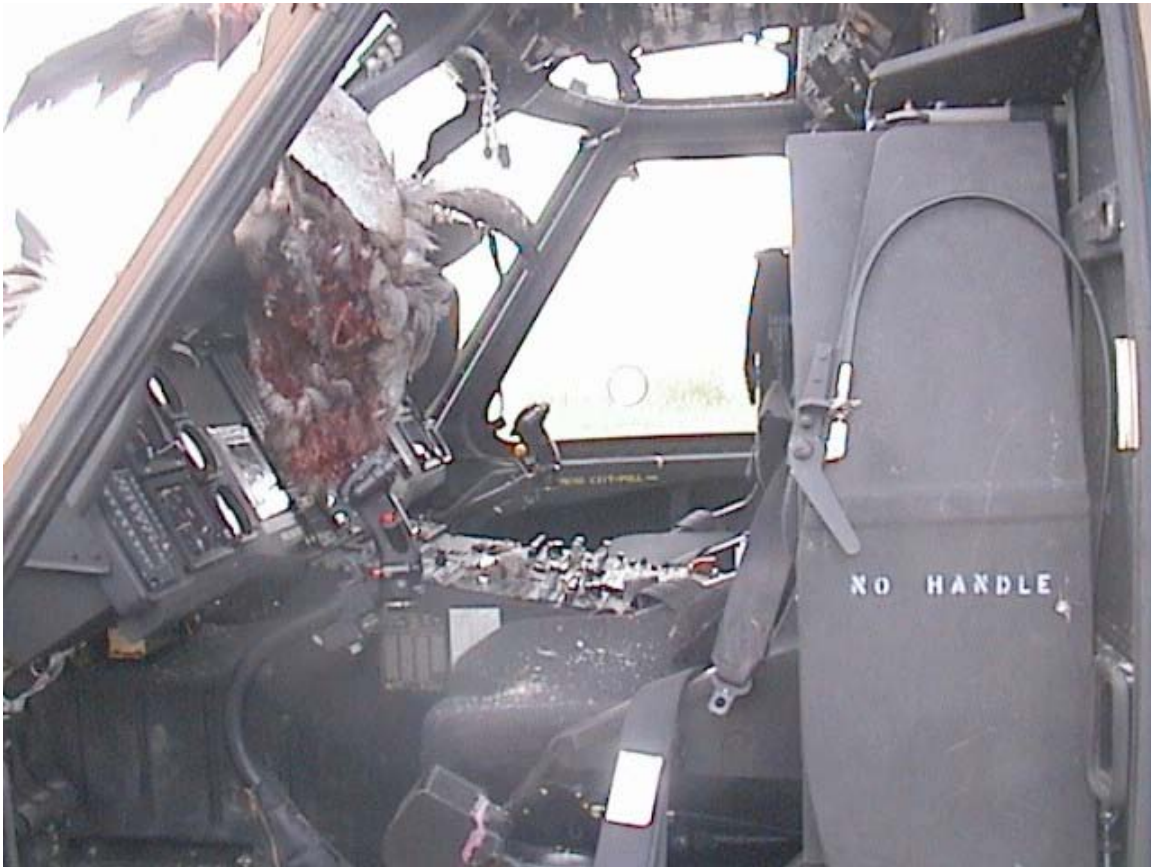
A UH-60 after collision with a crane, and subsequent failure of the windshield as seen from the inside
